## Endurance of the *Casuarina* coastal forest in southern Sri Lanka against the Indian Ocean tsunami

**Abstract:** In Hambantota, southern Sri Lanka, we implemented a survey of the damage-mitigating effect and the endurance of the *Casuarina* coastal forest against the Indian Ocean tsunami that occurred in December 2004. The tsunami struck by passing over the *Casuarina* forest on the front dune (height of 5.5m above sea level), but it was unable to pass over the next dune (height of 5m); therefore, private houses on the inland side of that dune were not damaged. In contrast, in the shallow trough produced by excavation of part of the dune, the tsunami passed over the front dune (height of 3.5m) and through the *Casuarina* forest; it destroyed private houses 250m from the shoreline. Although the *Casuarina* trees growing on the high dune were not damaged, 57% of the *Casuarina* trees that were directly hit by the tsunami on the trough withered after it passed. However, few tree trunks were broken during the tsunami, so it was suggested that the *Casuarina* forests had been able to withstand the physical impact of the tsunami.

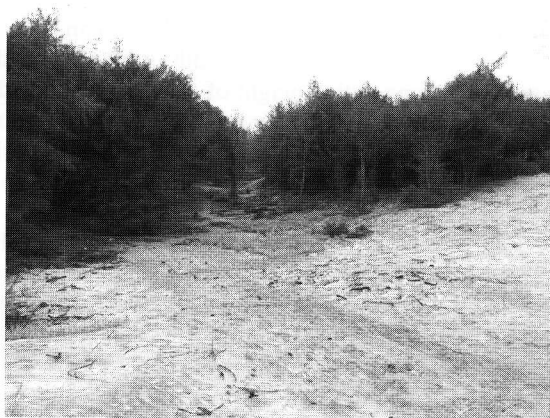
Near the salt-processing plant, a shallow trough was produced by excavation of part of the dune, with a width of 30 m and a length of 250 m (Photo 1). This trough was excavated to drain water to the sea when a flood occurred in an inland lagoon in 1970; in 1986, *Casuarina* trees were planted in the area, including this trough.

Photo 1. Inlet of the trough of the front dune as viewed from the sea side.

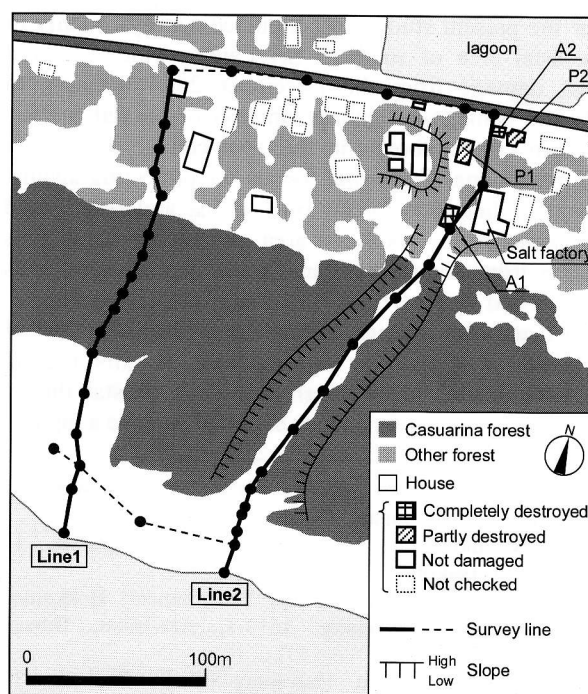
Fig.2. Locations of the two measurement lines and damaged houses. A map was prepared based on the actual state at the time of the survey.

The manager of the salt-processing plant had witnessed the tsunami that passed through the trough. During an interview, he testified that the tsunami was 2.5 m high. Two houses had been located on the extension line from the trough; the one (A1) on the sea side was totally destroyed, whereas the one (P1) on the inland side was only partially damaged (Fig. 2). Three residents in these houses were thrown into the inland lagoon, but all were rescued. Of the two houses along the national road near the plant, one (A2) was totally destroyed and the other (P2) was partially damaged.

With the exception of the trough, no place was found where houses were damaged by the tsunami passing over the dune. However, a resident confirmed evidence that the tsunami got over the first dune and reached a point nearly 150 m from the shoreline (Line 1 in Fig. 2). Furthermore, testimony indicated signs of tsunami intrusion into the trough by passing from the inlet of the trough and passing over the front dune to the east of it.

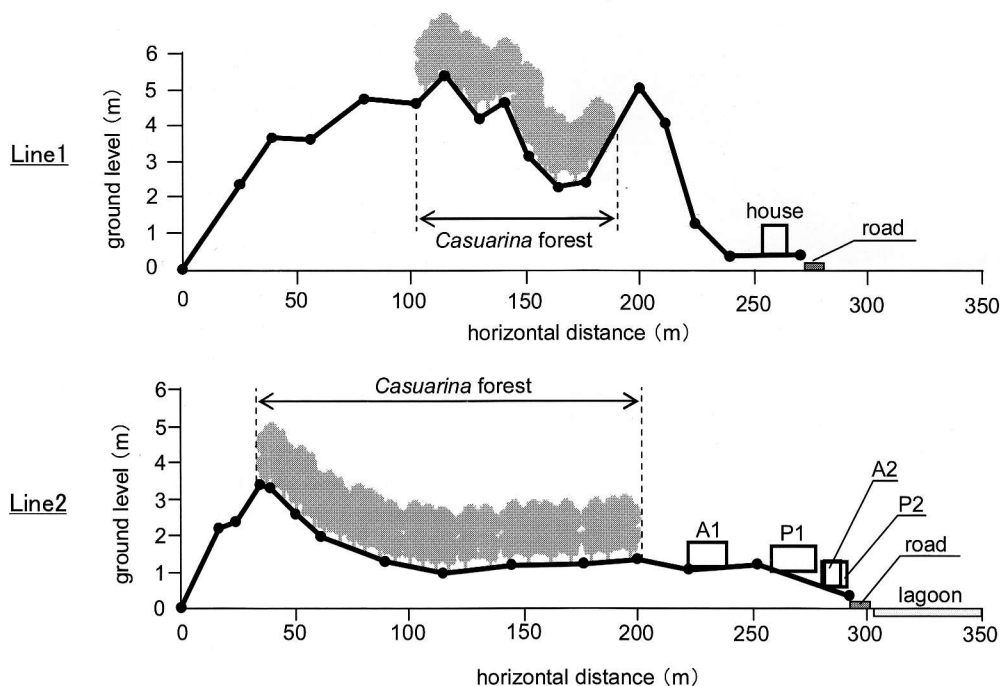
Figure 3. Longitudinal section from the shoreline to the national road along each measurement line, one on the dune and the other on the trough

Figure 3 depicts the longitudinal section from the shoreline to the national road of each dune (Line 1) and trough (Line 2). In this figure, Line 1 reaches the top of the front dune; it had a height of 5.5 m at a distance of 110 m from the shoreline, and then the height decreased to 2.5 m at a distance of 50 m from the top of the dune. From that point, the second dune began; after reaching the peak at a height of 5.1 m, the height decreased to 0.5 m at a distance of 240 m from the shoreline.

Along the trough (Line 2), the height peaked at 3.5 m at a distance of 40 m from the shoreline and then decreased gradually up to the national road. *Casuarina* trees had been planted in the section from this peak to a distance of 200 m.

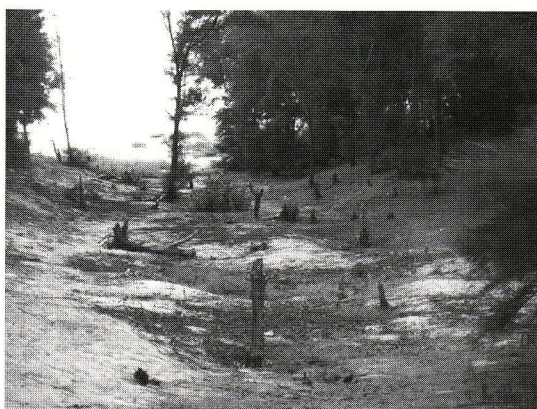
Photo 2. *Casuarina* trees felled after withering.

However, he also testified that many of *Casuarina* trees in the trough withered one week after the tsunami, and were then felled for use as fuel (Photo 2).

Forty-one (43%) of the 95 trees recognized in the belt transect as established on the trough were found alive, and 54 (57%) were found dead. Of those found alive, 10 were partially broken or cut, 5 had partially died, 7 had trunk damage, and 25 were sound with no damage at all. Most of the dead trees (96%) had been felled; only two were left standing, and they were withered. The trunks of nine trees, including those denuded and alive, were found to be inclining to the inland side.

Why *Casuarina* trees withered after the tsunami is not known. The *Casuarina* trees on the front dune (Line 1 in Fig. 2) did not wither, and the withering rate was higher among the trees on the sea side of the trough than among those on the inland side with a lower ground level. Thus, it is suggested that the cause of withering was not simply salt damage but multiple factors (e.g., damage to the root as a result of the tsunami's impact).
