Tsunami Disaster in Solomon Islands in April, 2007

— Field survey on the damage reduction effect of coastal forest —

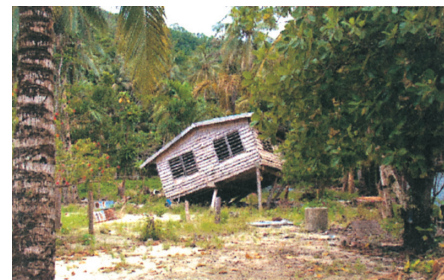
varied from approximately 50 to 300cm (Photograph 1). Most of the posts in raised-floor dwellings were wood, and some posts were concrete or iron material. As wall material, *Metroxylon sago* was used overwhelmingly, and it was sometimes used for wood, block material..

Photograph 1: Raised-floor dwelling of damage category 'impossible to reside'

Damage classification of houses was performed as follows. First, the stage in which the whole house remained was divided into three; 'not damaged', 'possible to reside' and 'impossible to reside'. Next, when only part of the house remained it was defined as 'severely damaged', and when a house was lost, it was classified as; 'only posts remaining', 'only base remaining' or 'washed away'. The results of this house damage classification are shown in Figure 3.

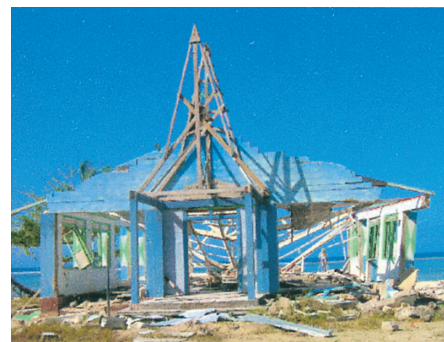
Photograph 2: Severely damaged church in Titiana

The photograph of the skeleton of the big church located on the seashore in Titiana was distributed all over the world, and became a symbol of this tsunami damage (Photograph 2). Although there were 80 or

more houses before the disaster, at the time of the investigation, only six houses were occupied dwellings and they were comparatively distant from the seashore. 13 out of 400 residents died. The maximum height of the tsunami is assumed to be about 3.8m, judging by a trace which remains near the window of the church. As shown in Figure 3, traverse line, Line-1, was set up and passed through the ruin of the church. Line-2, located about 70m west of it, passed along the side of a slightly damaged house whose distance from the shoreline was almost equal to that of the church. Figure 4 (a) shows that the frequency distribution of the height of posts of raised-floor dwellings which remained as house figures, i.e. belonging to the 'not damaged', 'possible to reside' or 'impossible to reside' categories, shifts towards a larger value, compared to all the houses in Titiana. It is considered that the tsunami flowed below the floor of the houses or the load on the houses caused by the tsunami was small because of the structure of raised-floor dwellings. Villages other than Hakaroa also show the same tendencies. From Figure 5, Line-1 and Line-2 are almost equal in ground height, and the tree density on the shoreline side of the house along Line-2 is clearly higher than that of Line-1. However, it cannot be determined whether this is an effect of the raised floor, or an effect of high density coastal trees, since this remaining house is a raised-floor dwelling with post height of approximately 200cm. Moreover, since Titiana suffered destructive damage over the whole village, it was difficult to evaluate the tsunami damage reduction effect of the coastal forest using other evidence. However an example of the secondary effect of coastal forest in which a *Cocos nucifera* became a support and stopped a moved house was recognized (Photograph 3).

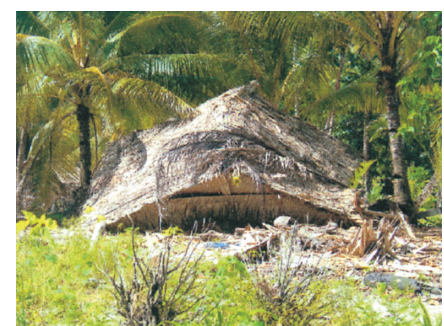
Photograph 3: A house stopped by a coconut palm tree
