The collision mitigation function of coconut palm trees against marine debris transported by tsunami

— A case study of Tangalla on the southern Sri Lanka coast —

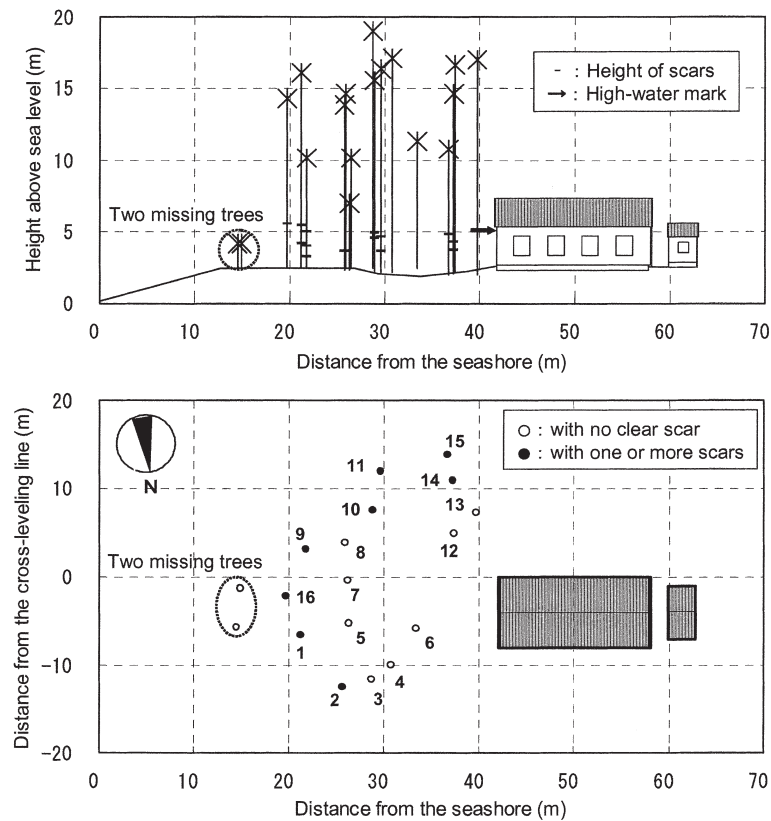
Figure 2 Layout of coconut trees and height of scars and high-water mark

The field survey was carried out at Tangalla, on the southern coast of Sri Lanka (Figure 1), where high-water marks of 1.6~3.8 m were recorded (Shibayame et al., 2005). The residents of a house located 30 m from the shore (that is, the boundary between the backshore and the foreshore; 2.2 m above sea level) had a high regard for the coconut grove, which was located between the shore and the house and was composed of 16 coconut trees. The height of the foundation of the house was 2.3~2.6 m above the sea level and was approximately the same as the shore (Figure 2).

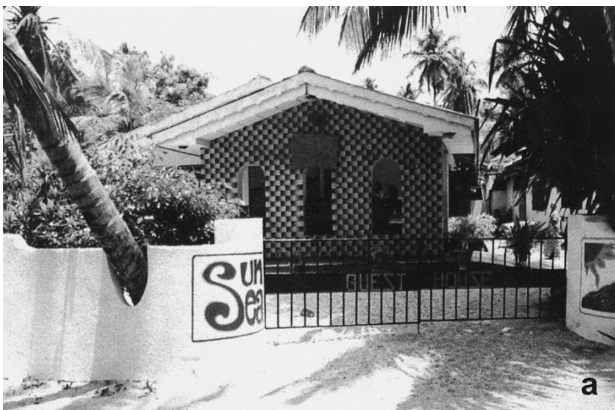
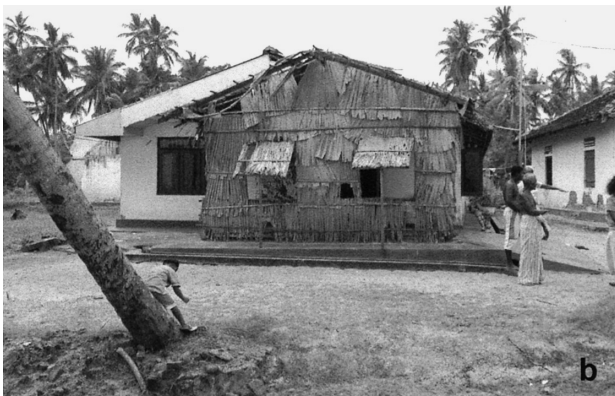
Photo 2: The entrance hall of this house was obliterated by the tsunami (a: before tsunami; b: after tsunami).

Although the first tsunami reached the house, and the door was open, it was prevented from entering the house by the 25cm-high doorsill. Since the residents of the house had experienced sea water reaching the gate wall on the seaward side of the house (refer to Photo 2a) during especially high wave activity, they thought at first that it was merely abnormal wave activity, even when the first tsunami came.

The tsunami destroyed the attached seaward portion of the house, and its gate walls (Photo 2). Some furniture in the house had disappeared, and some was pushed against the landward wall of the house. The residents do not know whether the furniture that had disappeared was all washed away by the tsunami or was stolen during their absence. Although sand, mud, garbage, coconut fronds, etc., were deposited in the house, there were no trunks or roots of coconut trees.

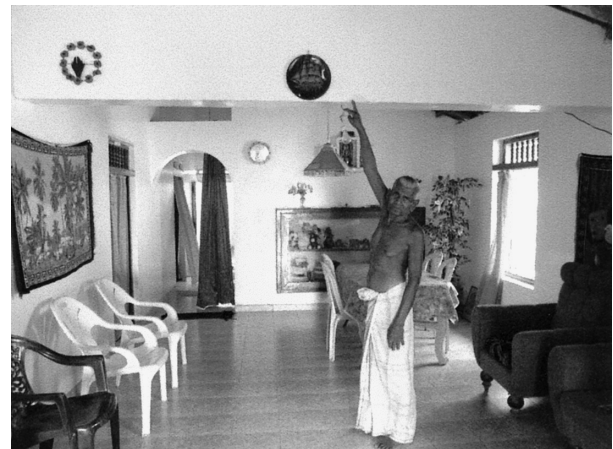
Photo 3: The tsunami reached the ceiling beam.

4.9 m above the sea level) and reached the beam (208 cm above the floor, Photo 3) that was attached to the ceiling.

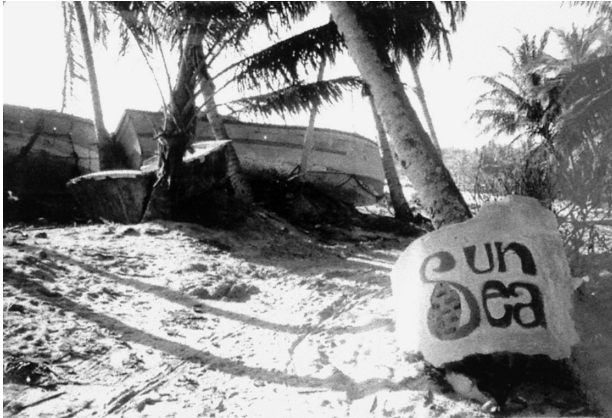
Depending on the account, from five to seven 40-foot class boats were blocked by the outer (seaward) coconut trees, or by other boats that had been blocked by the trees (Photo 4). There were also accounts of the inner (landward) side of the coconut trees acting to block the boats, too.

Photo 4: Boats were blocked by the coconut trees.

It was the seaward trees that blocked the inland movement of boats in this case. Although there were accounts that the inside trees had also blocked boats, no clear evidence was found on the trunks. Therefore, even if inside trees had blocked flotsam, it is presumed that the impact of the flotsam on the inside trees was weaker than that which the seaward trees received. Thus, even if it is a single row, a coconut grove has the potential to mitigate the damage caused by flotsam.

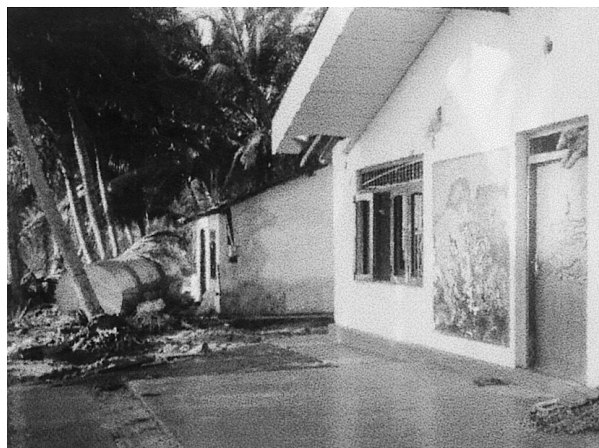
Photo 6: A tank carried by the tsunami (center left).

Except for one tree, the directions of the traces were seaward, from 57-148 degrees. The exception was the No.15 tree, on which a clear trace was detected on the trunk of the inland side at 328 degrees. According to the interview, this was not caused by a boat but by a tank that had been carried from the harbor located south of the site (Photo 6). One possibility is as follows: the tank passed between the No.15 and No.11 trees, hit the No.14 tree, and bounded back to collide with the No.15 tree from the inland side.
