Survey report of the damage caused by the April 2007 Solomon Islands tsunami in the villages of Siboro, Suva, and Pailongge, Ghizo Island — Investigating the effect of trees in reducing tsunami damage —

Abstracts: The April 2007 Solomon Islands tsunami caused extensive damage to the villages of Siboro, Suva, and Pailongge on Ghizo Island; out of 70 houses, all but five were destroyed by the tsunami and the earthquake. The effect of coastal forest in reducing the degree of damage caused by the tsunami was investigated. Since the mitigation of tsunami damage is not only affected by coastal forest but also by other factors such as tsunami scale, elevation, tide level, and the construction and strength of houses, it is difficult to isolate the effect of trees in reducing tsunami force. The structure of houses, building materials, elevation and the degree of damage were surveyed in the three villages. In addition, the tree spacing and distribution, species and size were recorded in the areas seaward of the residual houses. It was concluded that house structure and the number and characteristics of seaward trees determined the extent of tsunami damage.

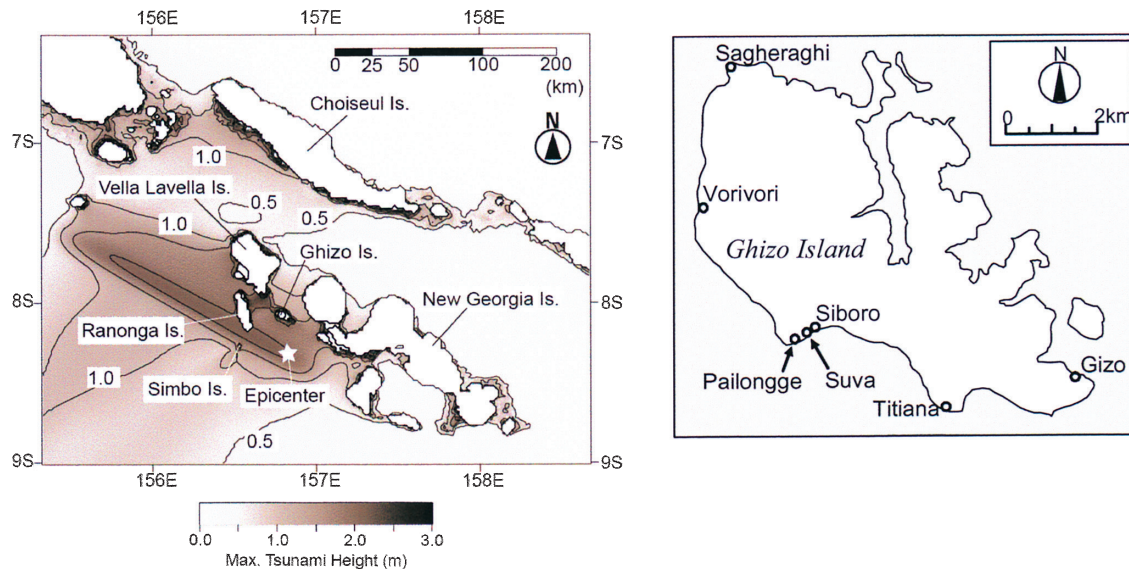
Figure 1: Location of Ghizo Island within the Solomon Islands, and the villages surveyed on Ghizo Island. The calculated maximum height of the tsunami in April 2007 around the islands is indicated

At 07:39 (local time UTC +11 hours) on the 2nd April 2007, an earthquake occurred in the Solomon Islands resulting in a tsunami which affected the Western Province, causing extensive damage to houses and infrastructure. The epicenter of the earthquake was located at 8.481° S, 156.978° E, which is approximately 340 km WNW of the capital Honiara, at a depth of 10 kilometers (Figure 1) [4].

The distribution of the maximum height of the tsunami around Ghizo Island was calculated (Figure 1). The maximum height of the tsunami was calculated at one-minute intervals by referring to the results of seismic analysis by the USGS [4]. According to these results, a tsunami measuring three to four meters in height occurred off Ghizo Island. This calculated height is considered to be appropriate compared with the results of the field survey.

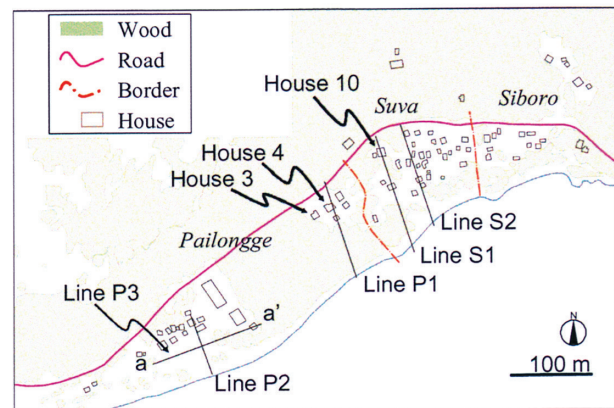
Figure 2: Diagram of the survey area in the villages of Siboro, Suva and Pailongge.

Line S1: Survey line passing the remaining House 10 in Suva

Line S2: Survey line passing all houses lost in Suva

Line P1: Survey line passing the remaining House 3 in Pailongge

Line P2: Survey line passing all houses lost in Pailongge

Line P3: Survey line normal to Line P2

precisely survey four parallel lines, S1, S2, P1 and P2, as well as a perpendicular line P3 (Figure 2).

Many of damaged houses were situated on flat land extending 150 m inland from the shore along a 700 m stretch of coastline (Figure 2). In Suva, the ground level was surveyed along two survey lines: line S1 passing surviving House 10 and line S2 passing a washed away area where all houses were lost (Figure 2). Although the lines S1 and S2 were similar, reaching approximately 2.0 m above sea level, line S2 was up to 0.2 m higher between 70 and 110 meters from the shoreline (Figure 3a). In Pailongge, the elevation of line P2, which runs along the destroyed houses, was 0.1 to 0.5 meters higher than line P1, which passed the still-standing House 4 (Figure 3a). The ground height of House 4 was 2.1 m.

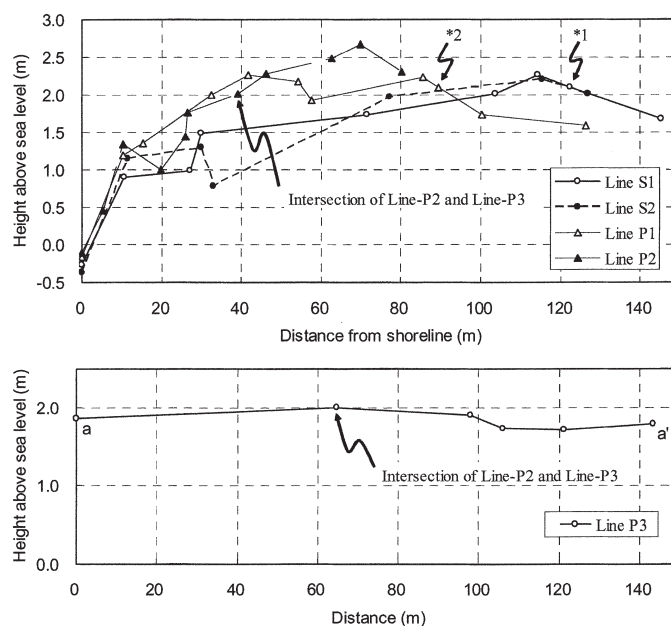
Figure 3: (a) Elevation above sea level along the survey lines S1, S2, P1 and P2, (b) Elevation above sea level along the survey line P3. Sea level is relative to that at the time of the tsunami (+0.59 m).

*1 : The position of remaining House 10 (seaward side)

*2 : The position of remaining House 4 (seaward side)

House 10 was located 100 m from the shoreline and had floors 1.80 m high and Sago palm walls. This house was classified as 'possible to reside within' although its posts leaned a little (Figure 10). High water marks were found on the wall 2.0 m above the ground, and the house is 2.1 m above sea level (Figure 3). House 3 was located 80 m from the shoreline with floors 1.40 m high and Sago palm walls. Although the house leaned after the tsunami, it became 'possible to reside within' after being pulled upright. A dead trunk of a Buni tree 'which was so big you could not put your arms around it' was deposited beneath the floor by the tsunami (Figure 10). This trunk was previously described as lying at the shoreline. House 4, which was 10 m from House 3, had a raised floor measuring 2.0 m with concrete posts and wooden walls, and an elevation of 2.1 m relative the ground level (Figure 3). House 4

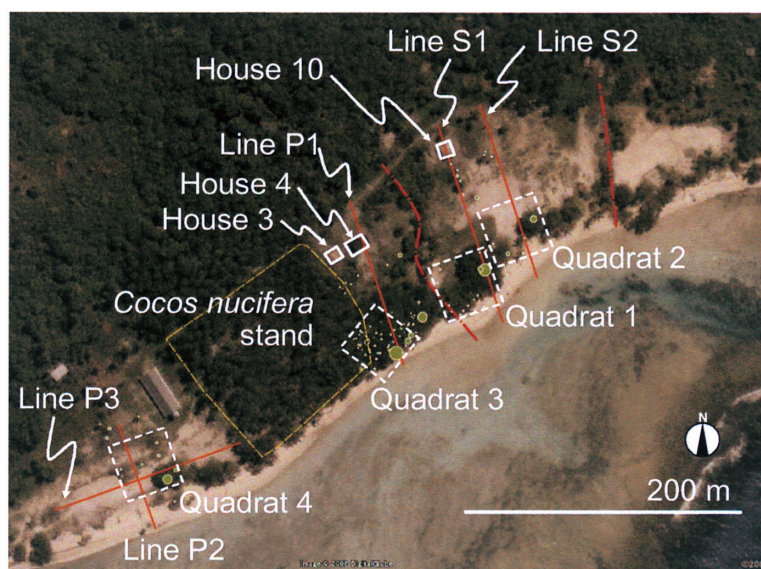
Figure 4: Distribution of trees surveyed in the survey area. Circles indicate individual trees measured. The sizes of the circles correspond to their diameters. The image was sourced from Google Earth.

There were few trees in the residential area (Figure 4, Table 2), and most trees grew in four areas: inland of the residential area, along the coast, near the border between Suva and Pailongge especially near the shoreline, and also in a *Cocos nucifera* stand on the western of the border of Suva village (Figure 4). The Google Earth image (Figure 4) shows that the trees along the coast of Suva and Siboro formed a continuous forest, but this stand comprises of mainly *Cocos nucifera*, Dewli (*Guettarda speciosa* L.), Bakabaka (*Hernandia sonora*), Talise (*Terminalia catappa* L.) in a single line at intervals from several meters to less than twenty meters. Similar species were found at Pailongge, but these were individual trees and their crowns were not continuous. In contrast, the *Cocos nucifera* stand to the western border of Suva covered 1.2 ha. The stand density was 400 trees/ha, the mean breast height diameter was 32 cm and the maximum tree height was 24 m. In addition to the species mentioned above, Pututu (*Barringtonia asiatica*), Buni (*Calophyllum inophyllum* L.), Vivinene (*Cordia subcordata*), Ivili (*Instia bijuga*), Sube, Tenon, Nute (*Morinda citrifolia*),

Premna sp and *Scaevola sericea* were found growing in quadrats 1 and 3. Six trees, including *Cocos nucifera* and the Christmas tree (*Delonix regia*), formed a line to the shoreline in front of the still-standing House 10 (Figure 4).

Stand density, measured using four 40 x 40 m quadrats, varied depending on location (Figure 4). Stand density and stand basal area were 119 trees/ha and 36.8 m²/ha in Quadrat 1, 31 trees/ha and 10.4 m²/ha in

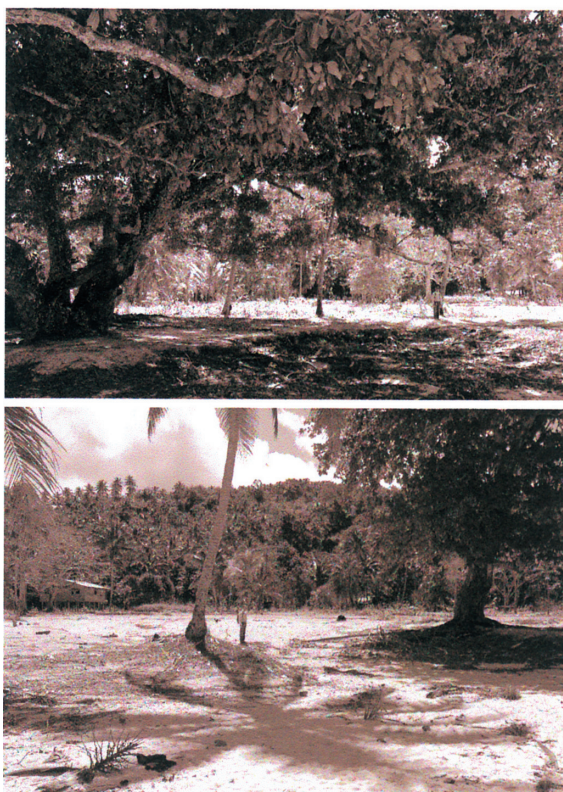
Figure 5: Difference in visibility along the survey lines S1 and S2 caused by tree density a. Line S1, b. Line S2 (photographed by Sakamoto, on June 19, 2007).

Quadrat 2, 313 trees /ha and 59.5 m²/ha in Quadrat 3 and 44 trees/ha and 21.1 m²/ha in Quadrat 4. The difference in the stand basal area was smaller than that in the stand density because there was at least one large tree, which was more than one meter in diameter at breast height in each quadrat. Where the stand basal area was the same, the resistance of trees against a tsunami may be more effective where there are many relatively thin trees than one tree with a larger diameter. Due to the density of trees, the visibility along line S2 (Figure 5b) from the shoreline was markedly better than along line S1 (Figure 5a).

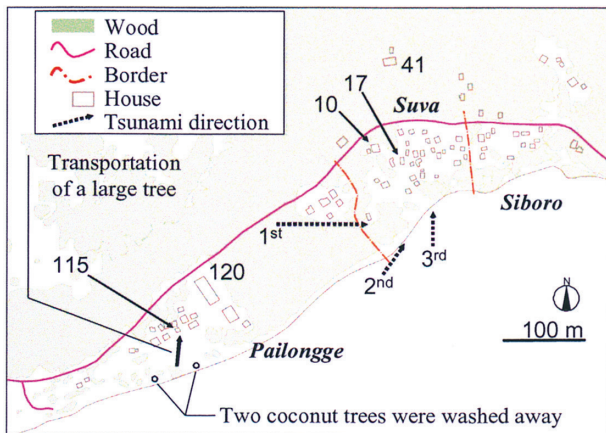
Figure 6: The distribution of houses in Siboro, Suva and Pailongge before the tsunami and the direction of tsunami waves based on accounts of local residents. Each digit is a structure number. The debris of House 17 was found west of the Church 120.

The third wave also struck the island perpendicularly and it was described as the largest at a height of approximately twelve feet. The third wave washed almost all objects that the second wave had destroyed westward towards the sea. For example, the debris from House 17 in Suva was found in Pailongge, west of the new Church 120 (Figure 6), which was under construction at the time of the event.

much to the west. The third wave must have come more from the east because it was observed to carry debris westward. Based on these considerations, the first wave may have come from a direction approximately 60° east of the direction indicated in Figure 6, and 35 to 40° for the second and third wave.

Two *Cocos nucifera* trees from the shoreline in Pailongge were washed away (Figure 6). Buni trees which had lain on the shoreline were carried approximately 40 m inland to near House 115.

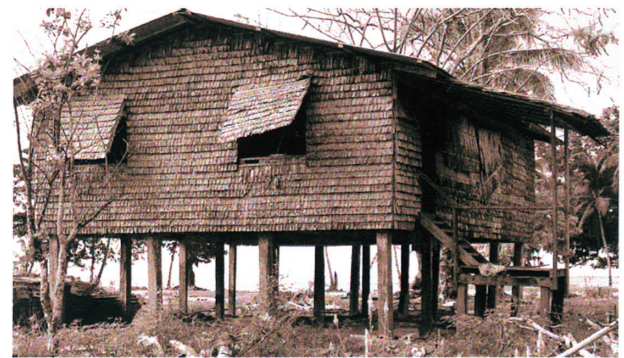
Figure 7: House 10: a typical house with raised floors with walls made of Sago palm fronds (photographed by Sakamoto, on June 19, 2007).

Seventy houses in the tsunami-affected area were surveyed. These included 58 with raised flooring and 12 with low floors (Table 3). Sixty-two of the 70 houses in the survey area had walls made of Sago palm (*Metroxylon sago*) fronds (Figure 7). The houses with raised flooring had posts with heights that varied from 0.3 to 2.0 m. The walls made of Sago palm fronds may be the reason why such houses floated on the wave and were deposited with little damage, since this material is

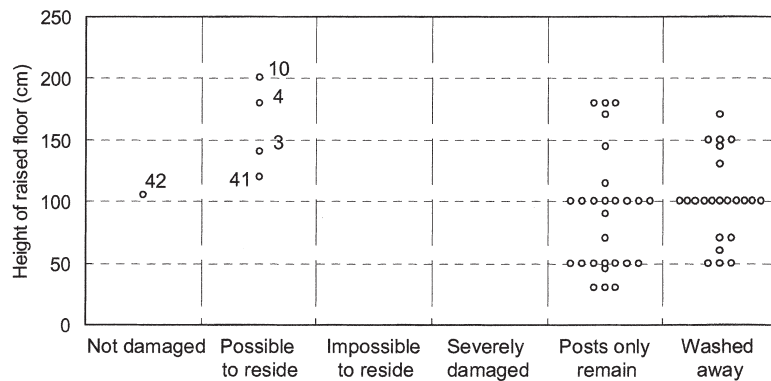
Figure 8: The degree of damage to houses relative to the height of the posts of houses with raised floors. Digits indicate house number.

Higher floors may have a lower-associated risk of tsunami damage because the water may flow beneath the elevated floor, as long as the posts are not brought down. The houses which could be classified as 'possible to reside within' had posts of at least one meter high, while houses with posts less than one meter were lost (Figure 8). Interestingly, of the seven that had floors higher than 1.5 meters, five were lost. In short, although all houses that had raised floors with low posts were lost, those with tall posts did not necessarily remain standing and other factors influenced the degree of damage.

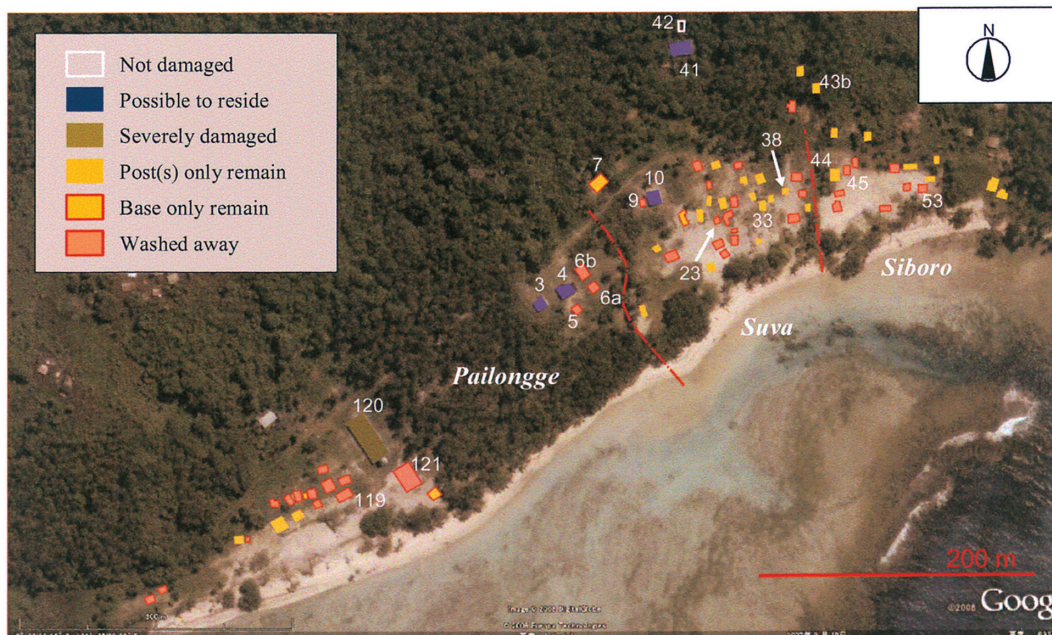
Figure 9: Distribution of structures showing the degree of damage by the tsunami in the villages of Siboro, Suva and Pailongge. The image was sourced from Google Earth.

Five houses, Houses 3, 4, 10, 41 and 42, were classified as 'possible to reside within' in the tsunami-affected area (Figure 9). These houses were located relatively far from the shoreline, but other houses located at the same distance from the shoreline were lost. House 41, which was the only house with iron posts, was located 185 m from the shoreline and had a floor height of 1.20 m and wooden walls. House 42, which was located a few meters inland of House 41, had a raised floor of 1.05 m and its walls were made of Sago palm fronds. These two houses were relatively isolated from the flat bare area where most damage to houses occurred and were separated from the bare area by a 50 m-wide wood of Sago palms and other species. High water marks were found on the wall of a tool shed with a raised floor of 1.05 m a few meters seaward of House 41, but it was only slightly damaged. The tsunami did not reach the floors of Houses 41 and 42. The only damage to House 41 was erosion around the posts and even this did not

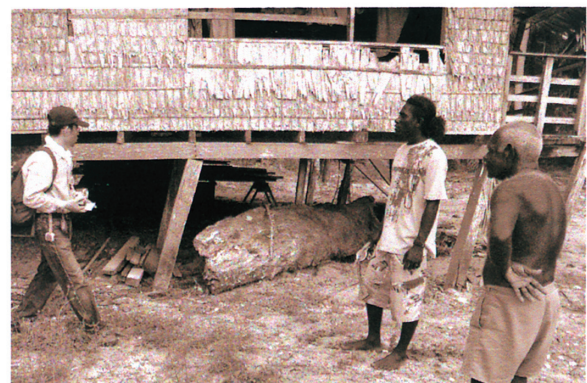
Figure 10: Photo of House 3 after the tsunami showing its leaning posts and the dead trunk of a Buni tree deposited beneath the floor (photographed by Sakamoto, on June 19, 2007).
