## Recurrence of sediment discharge in the riparian zone of a granite basin based on the analysis of terrace deposits in Kagoshima prefecture

Yuki Yoshi Teramoto<sup>1\*</sup> and Etsuro Shimokawa<sup>1</sup>

**Abstract:** To determine the recurrence of sediment discharge in the riparian zone of a granite basin in northwestern Kagoshima based on analysis of terrace deposits, aerial photograph interpretation, soil survey and soil profile analysis were carried out. Slope failure has occurred repeatedly in the basin. Slope failures were distributed mainly on slopes >30 degrees in the lower and middle reaches of the basin, and occurred both at sites of previous failures and sites where no previous failures have been observed. Number of sediment discharge events via bed load transport and debris flow was between 4 times and 7 times based on terrace deposit analysis, and relatively large-scale sediment discharges have also occurred several times. The recurrence of sediment discharge was correlated with slope failure in the basin.

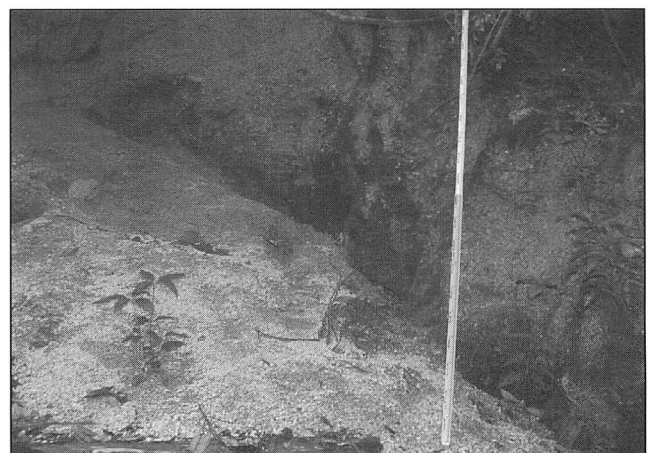
Photo 1: Grus observed in the study basin

The geology of the study basin comprises granite, the surficial zone of which consists of grus caused by granite weathering. The grus has a thickness >20 m in the basin (Photo 1).
